RILEY PASS NEWSLETTER

MARCH 2014

This newsletter provides information regarding ongoing reclamation work at the Riley Pass Abandoned Uranium Mines Site. Riley Pass is in the North Cave Hills portion of the Custer National Forest's Sioux Ranger District, approximately 25 miles north of Buffalo, SD.

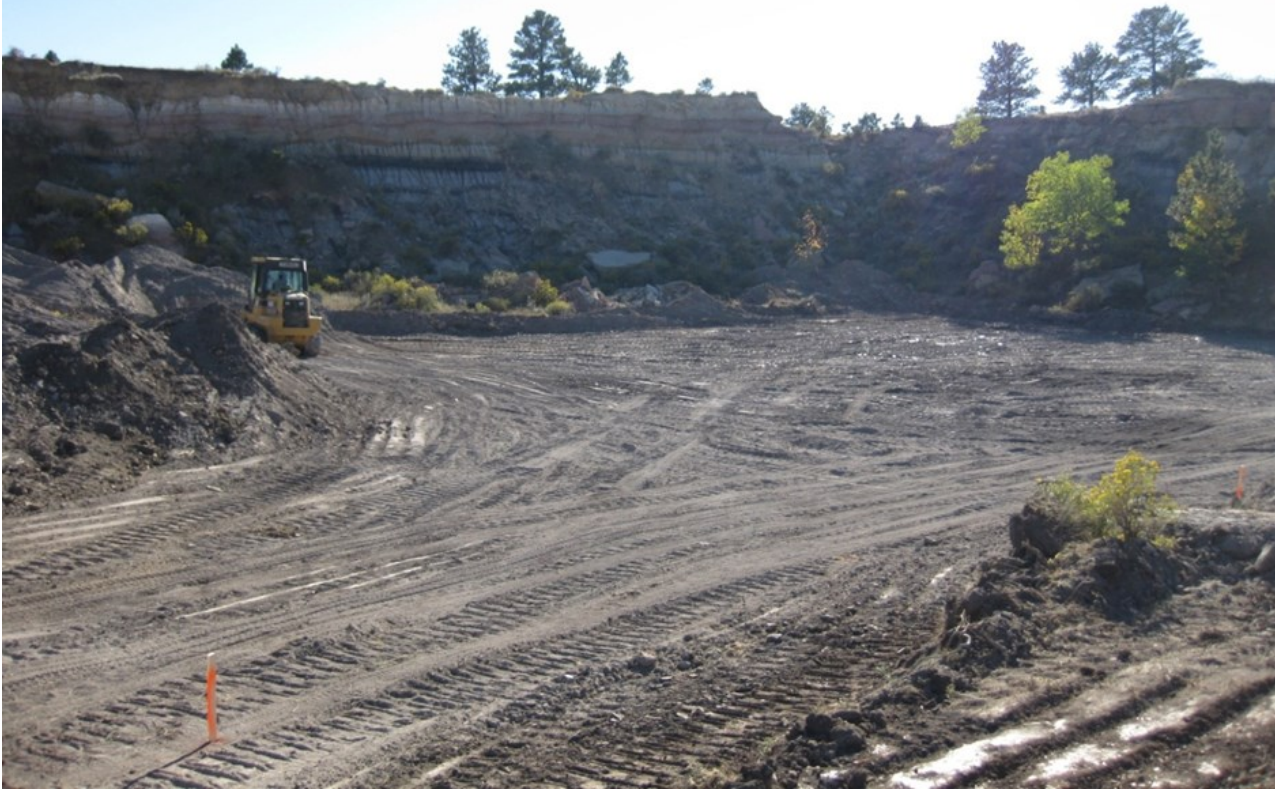
Figure 4. Preparing the Bluff I-1 repository. September 2012.

- 3) **Repository construction:** Repository construction consists of preparing a clean, flat surface upon which waste will be placed. Riley Pass repositories have been located against the excavated faces of areas disturbed by mining, which are called highwalls. These areas are scraped clean down to the underlying sandstone or compacted waste (Figure 4). Where sandstone has significant cracks, bentonite clay is used to plug the cracks (Figure 5). A similar repository construction approach is proposed at the Tronox bluffs.

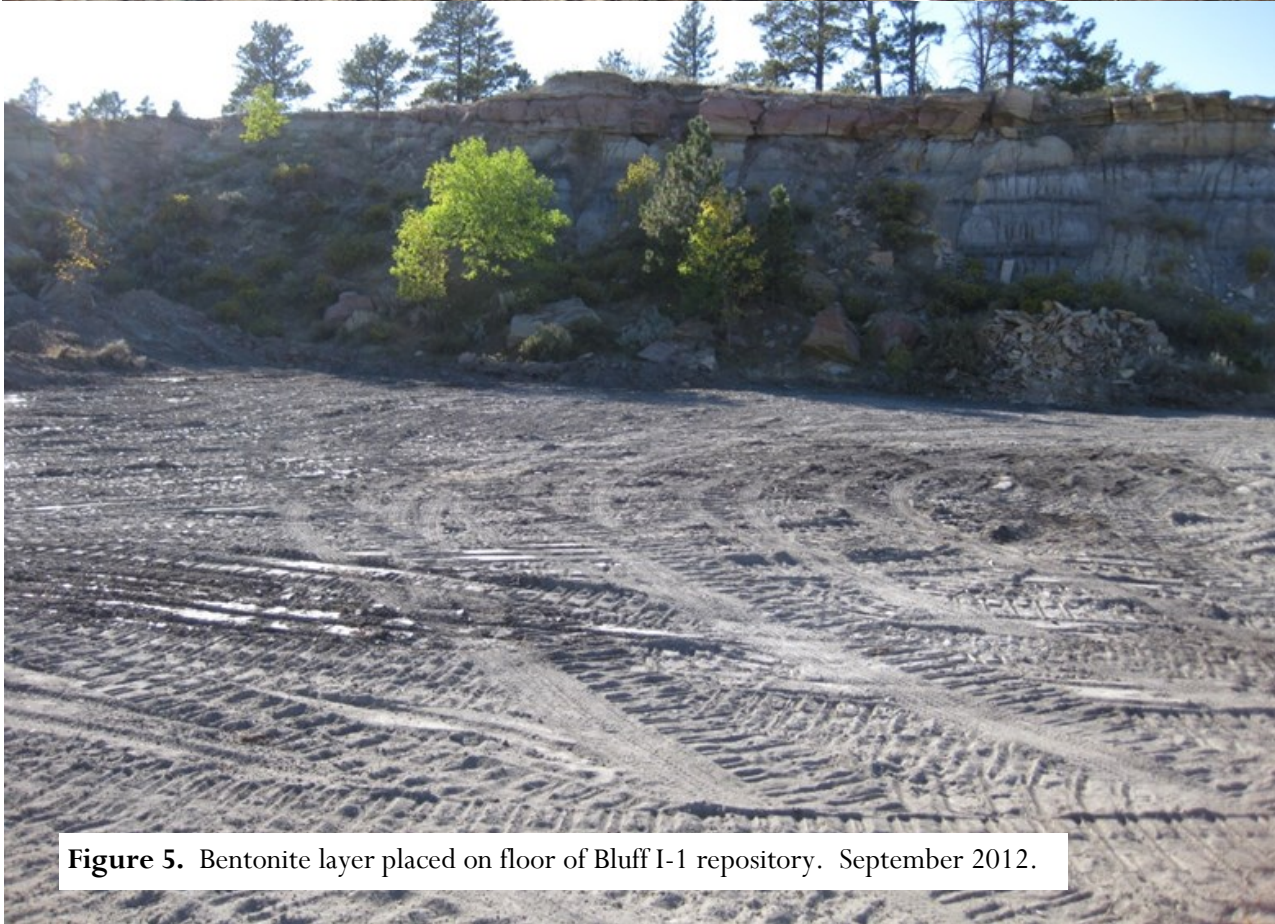
Figure 5. Bentonite layer placed on floor of Bluff I-1 repository. September 2012.

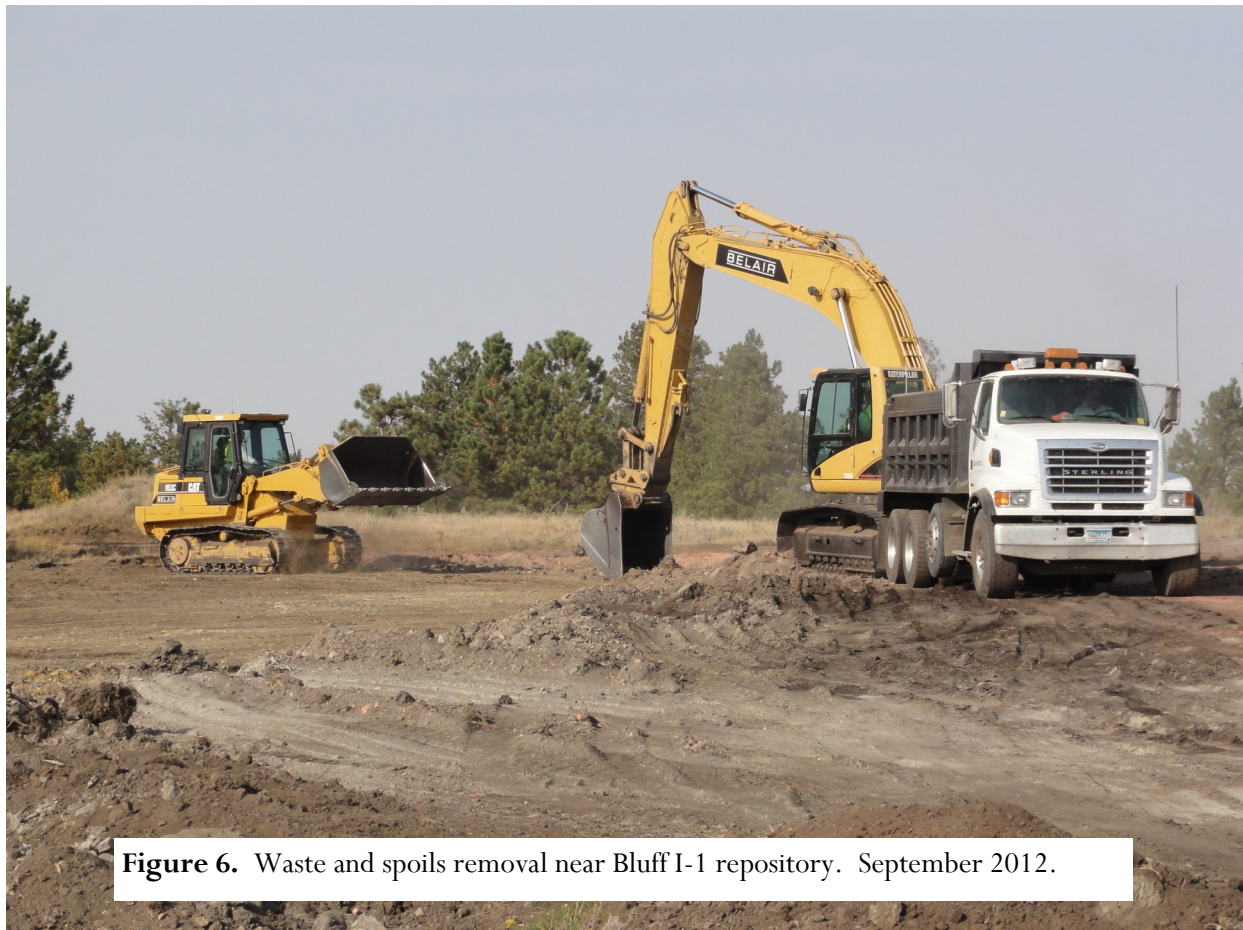
Figure 6. Waste and spoils removal near Bluff I-1 repository. September 2012.

- 4) **Waste and spoils removal and compaction:** After the repository site is prepared, mine waste around the bluff is removed and brought up to the repository (Figures 6 to 9). At the repository, equipment is used to compact waste in place to ensure that water will not infiltrate through it. To isolate the waste and reduce potential for radiation exposure, spoils are removed from nearby areas and used to cover the compacted waste. Spoils are then further compacted. Throughout the process, engineering tests are completed to ensure that compaction will prevent water infiltration (Figure 10). Due to the size and costs associated with Bluff I-1 reclamation, work has consisted of multiple phases since 2012. Reclamation at I-1 will be completed in 2014 or 2015, dependent upon funding. Future Tronox bluffs work is anticipated to take several more years, dependent upon funding.

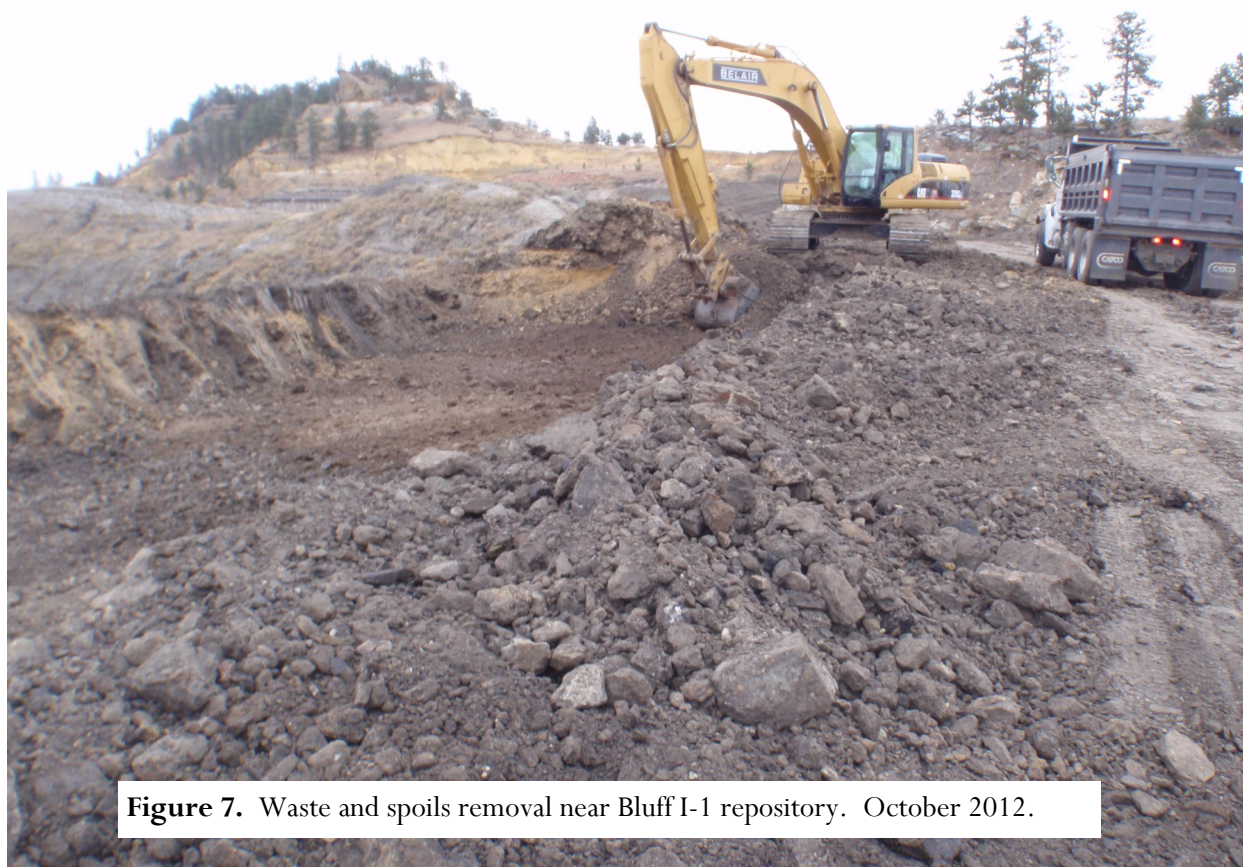
Figure 7. Waste and spoils removal near Bluff I-1 repository. October 2012.

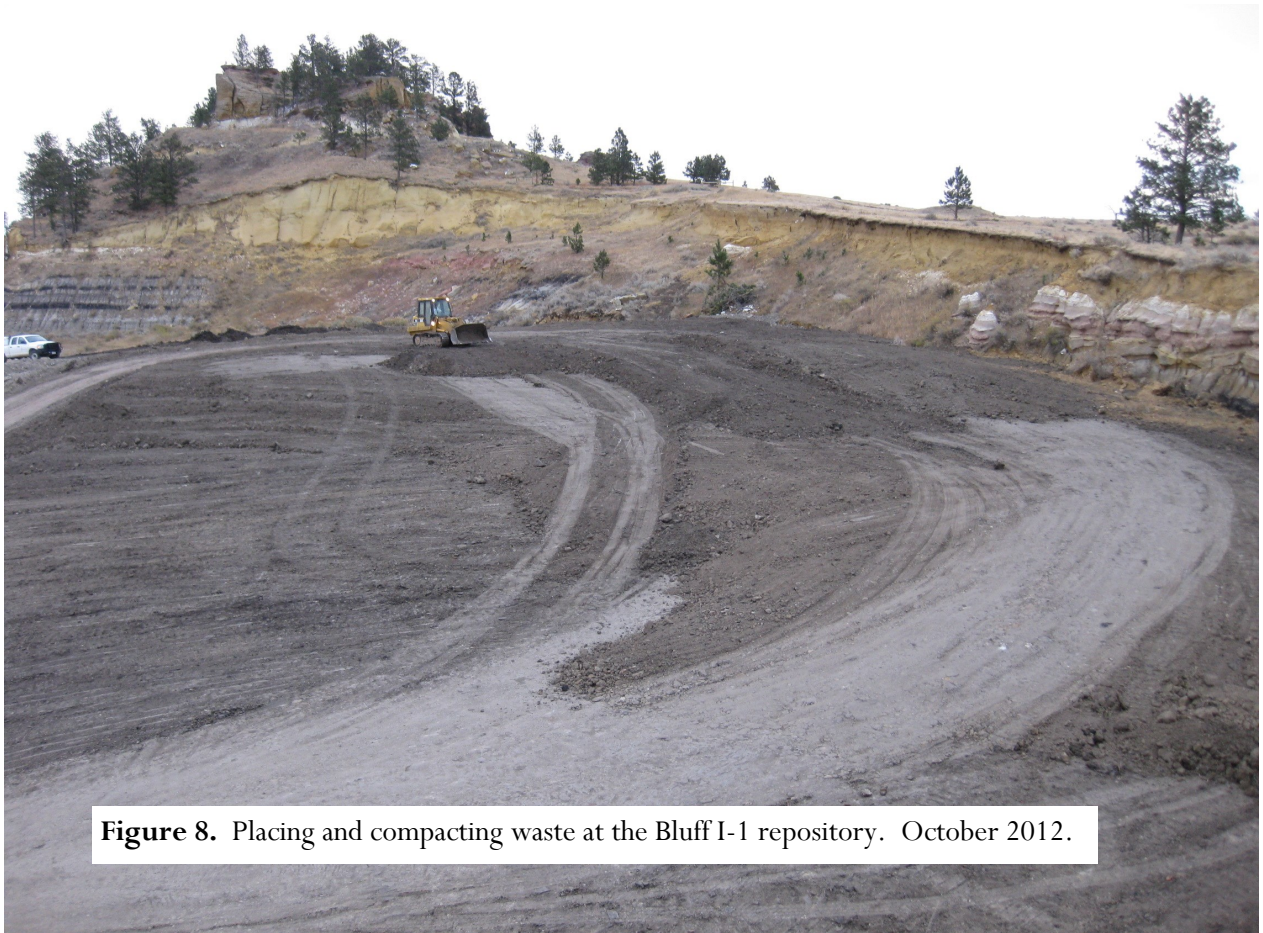
Figure 8. Placing and compacting waste at the Bluff I-1 repository. October 2012.

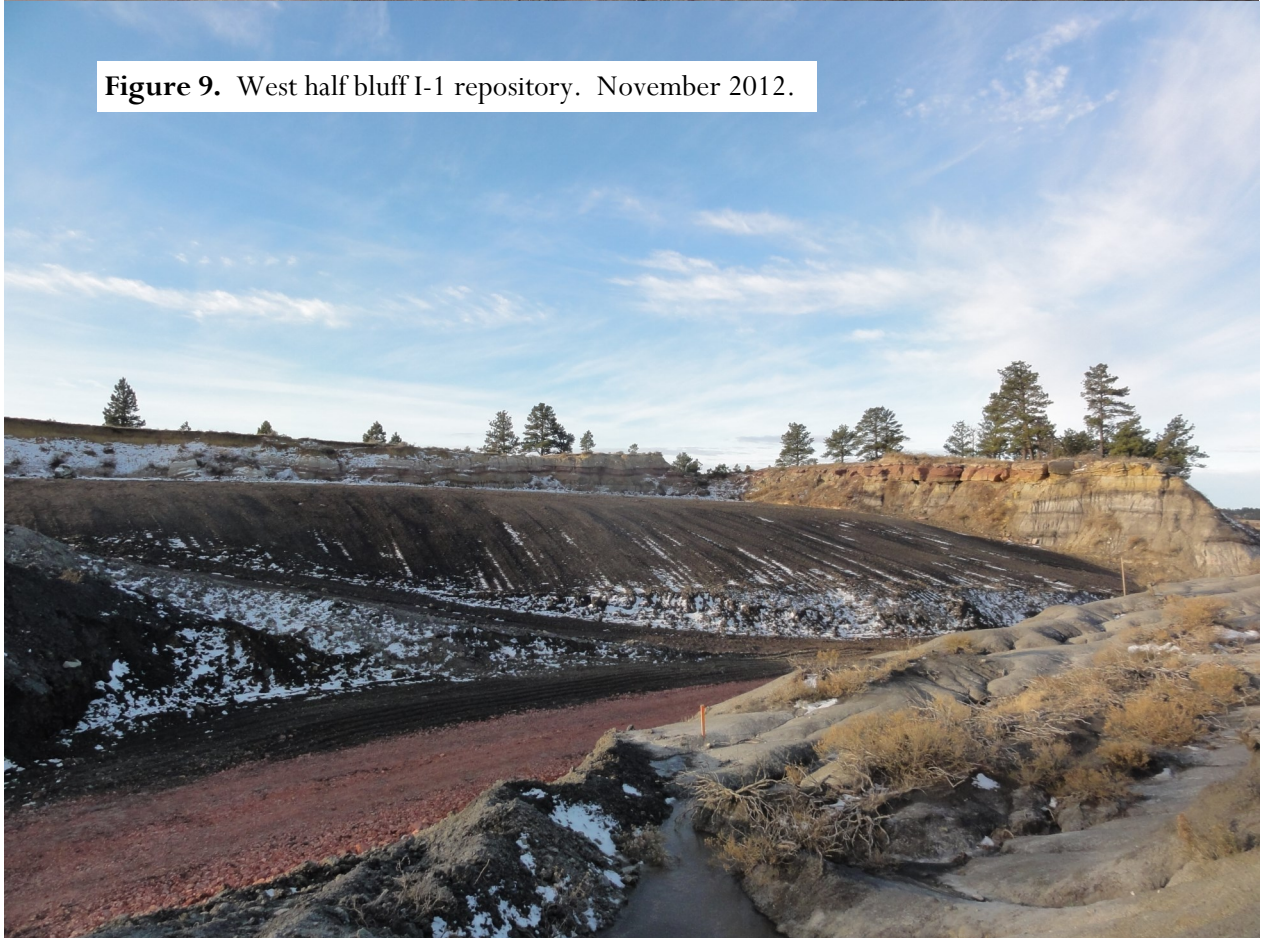
Figure 9. West half bluff I-1 repository. November 2012.

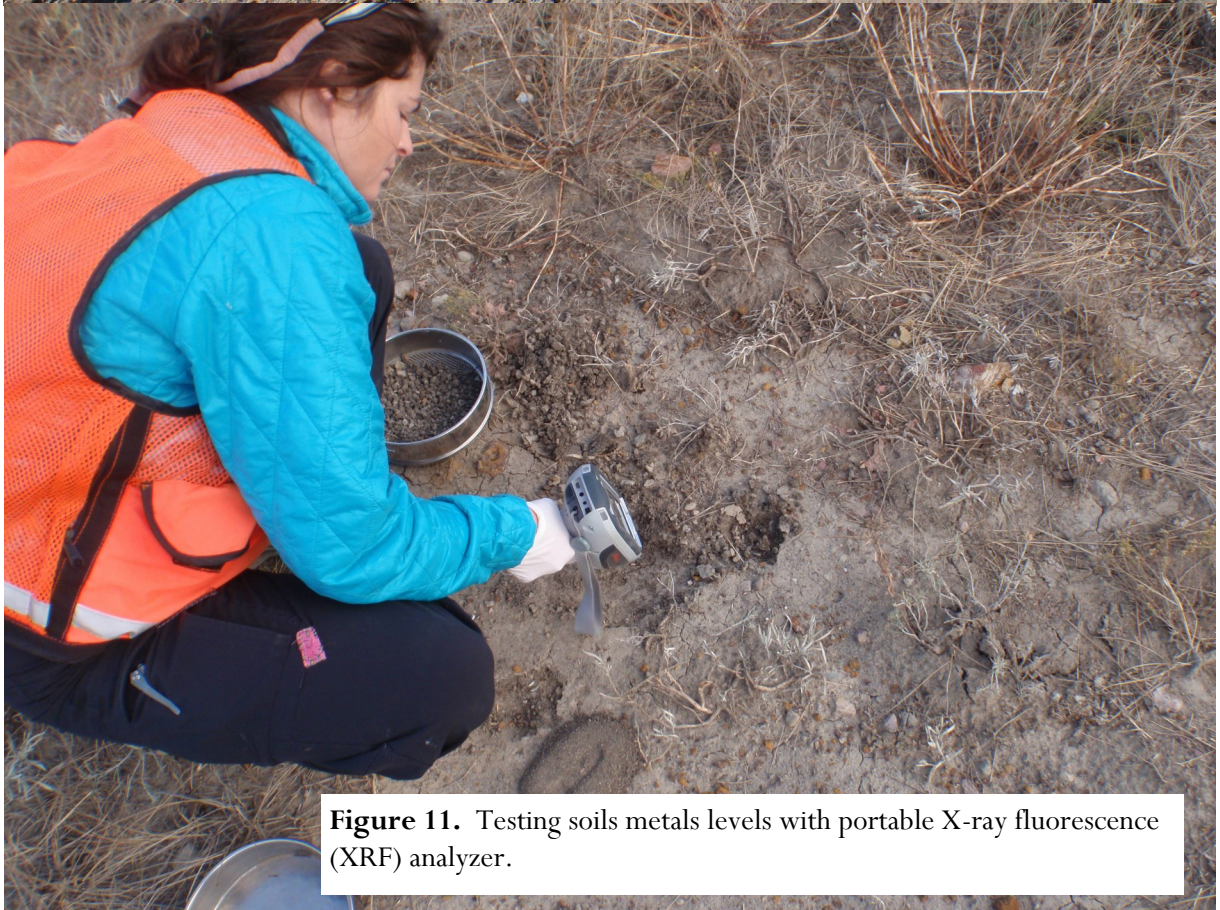
Figure 11. Testing soils metals levels with portable X-ray fluorescence (XRF) analyzer.

- 5) **Removal area testing and reclamation:** After waste and spoils are placed in the repository, gamma radiation and soil metals surveys are completed to verify that all waste materials have been removed and that the repository has been adequately capped (Figure 11). If test results show areas of elevated radiation or metals, additional removal and capping are completed.

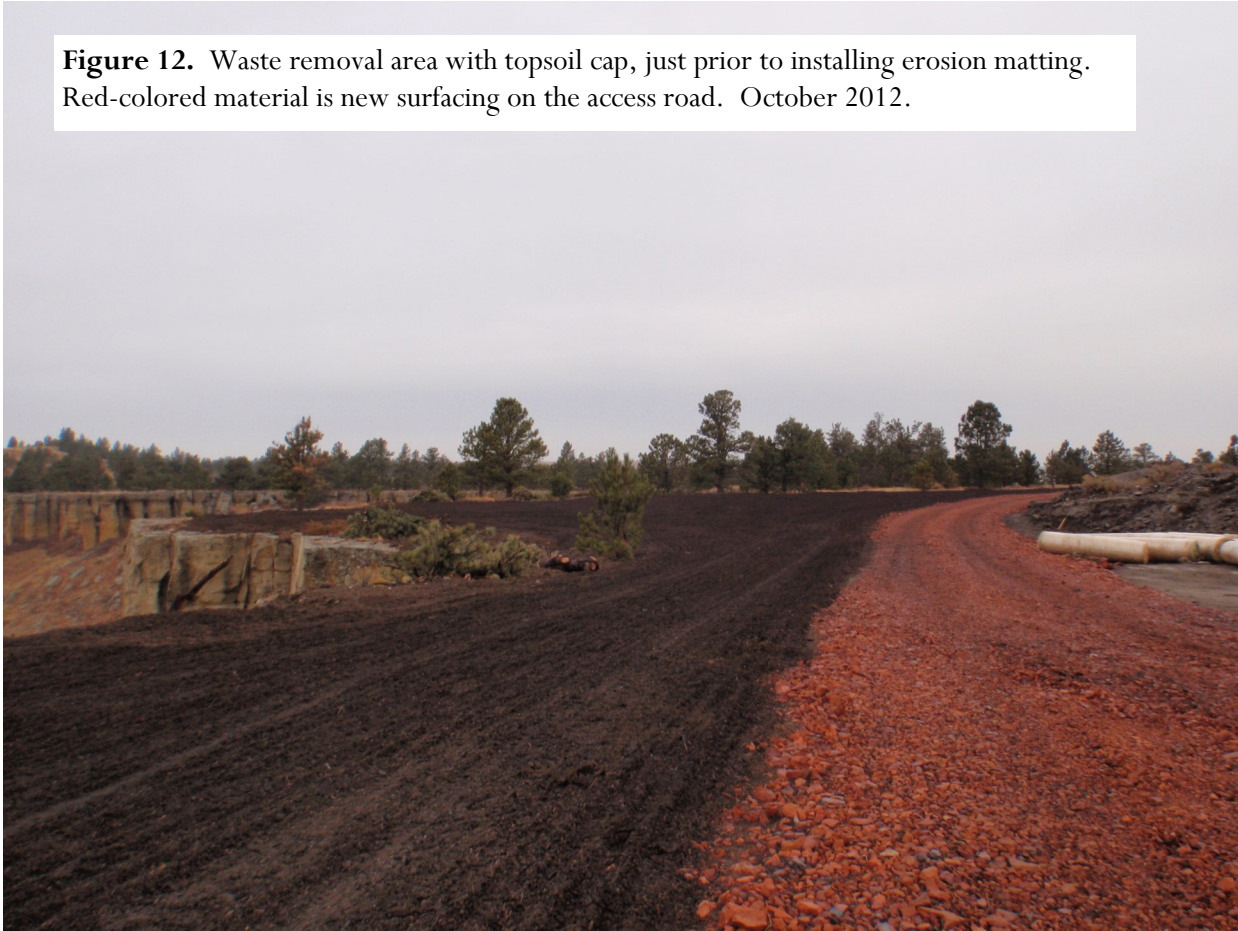
Figure 12. Waste removal area with topsoil cap, just prior to installing erosion matting. Red-colored material is new surfacing on the access road. October 2012.

- 6) **Cover and re-vegetate removal and repository areas:** Once all waste has been removed, repository and removal areas are stabilized by covering them with topsoil, compost, seed, and erosion matting (Figures 12 and 13). Several areas have been examined to identify potential topsoil borrow areas. To ensure that erosion that does not expose the waste in the future, the goal is to establish a thick grass cover on the repository surface. Fencing is installed around all reclaimed areas to prevent cattle from impacting the erosion matting and new vegetation.

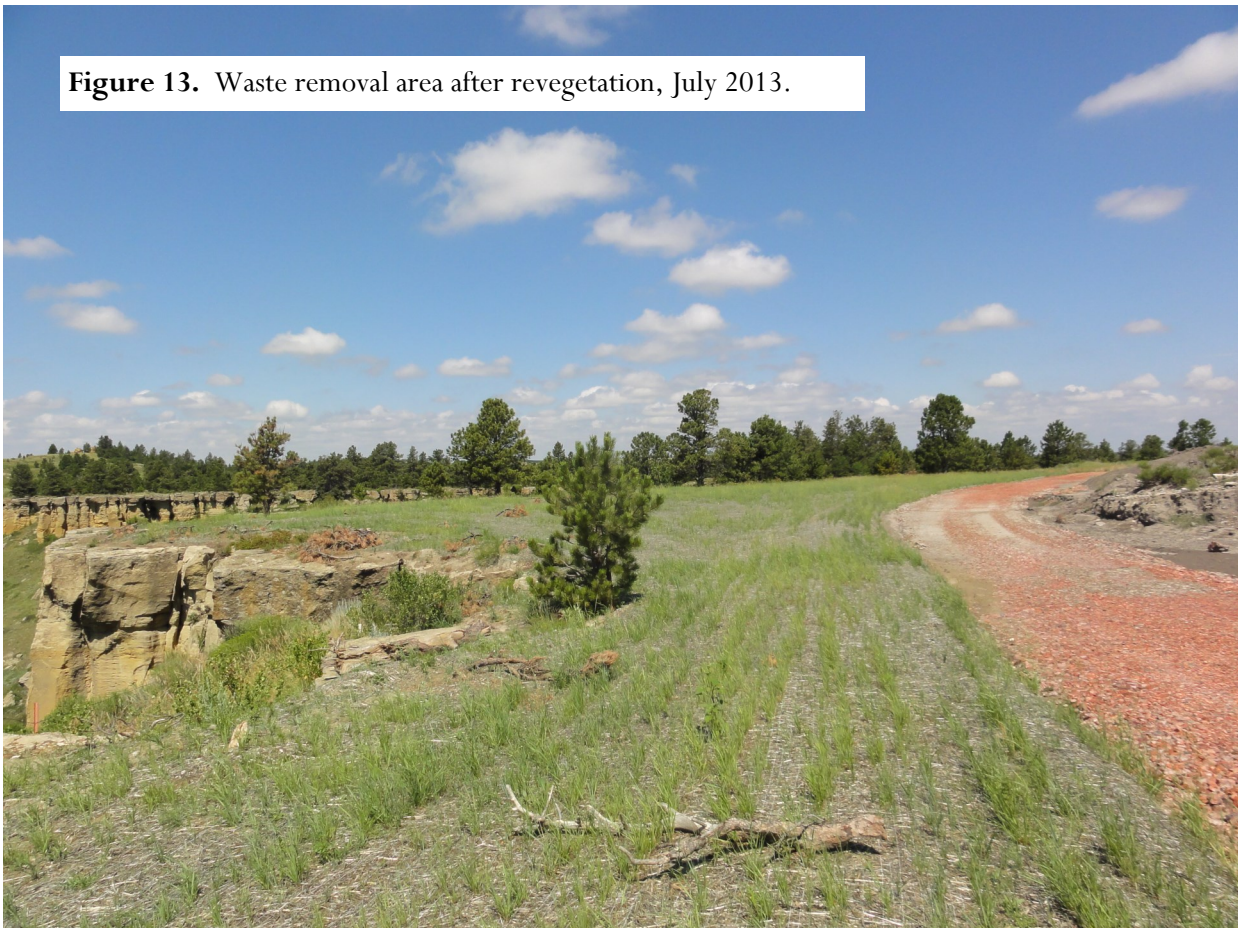
Figure 13. Waste removal area after revegetation, July 2013.
